GRIDLEY SWIMMING POOL
Gridley, California

**REHABILITATION / RENOVATION
FEASIBILITY REPORT**

February 22, 2016

Prepared By
SIEGFRIED ENGINEERING, INC.
111 Scripps Drive
Sacramento, CA 95825

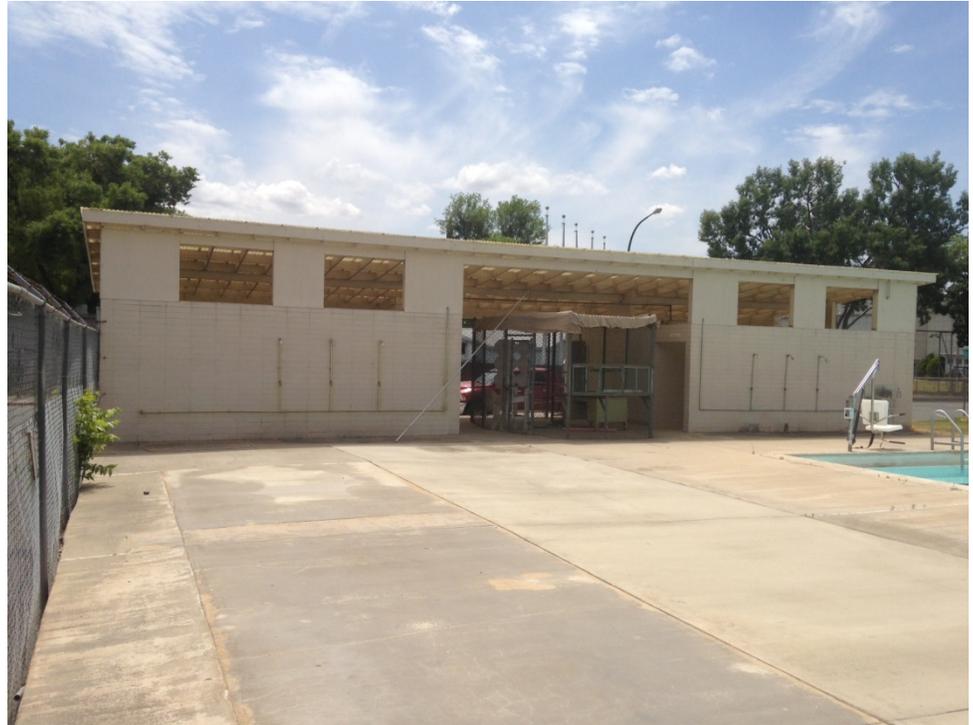
Photo 01
Bathhouse

- f. The site is fenced on all sides. The existing fencing is not code compliant.
2. Bathhouse:
 - a. Architectural Layout and Features:
 - 1) The bathhouse was constructed in 1970 of masonry walls, wood framed flat roof, and concrete floors. The bathhouse is essentially two separate dressing and toilet areas for each sex separated 18 feet to provide the open air entrance to the facility. *(See photo 01.)*

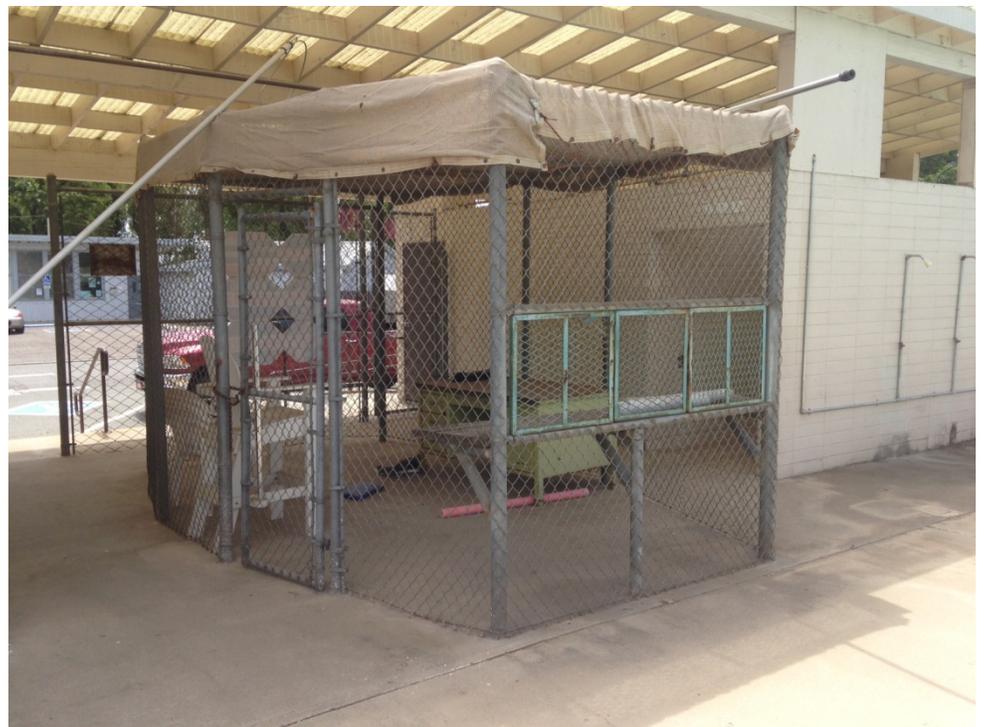
Photo 02
Check In Cage

- 2) User check-in is provided within a chain link enclosed attendant station. *(See photo 02.)*
 - 3) Natural light and ventilation are provided by large openings between the top of the perimeter walls and the roof structure above, as well as corrugated translucent panels which comprise the roof deck. *(See photo 03.)*

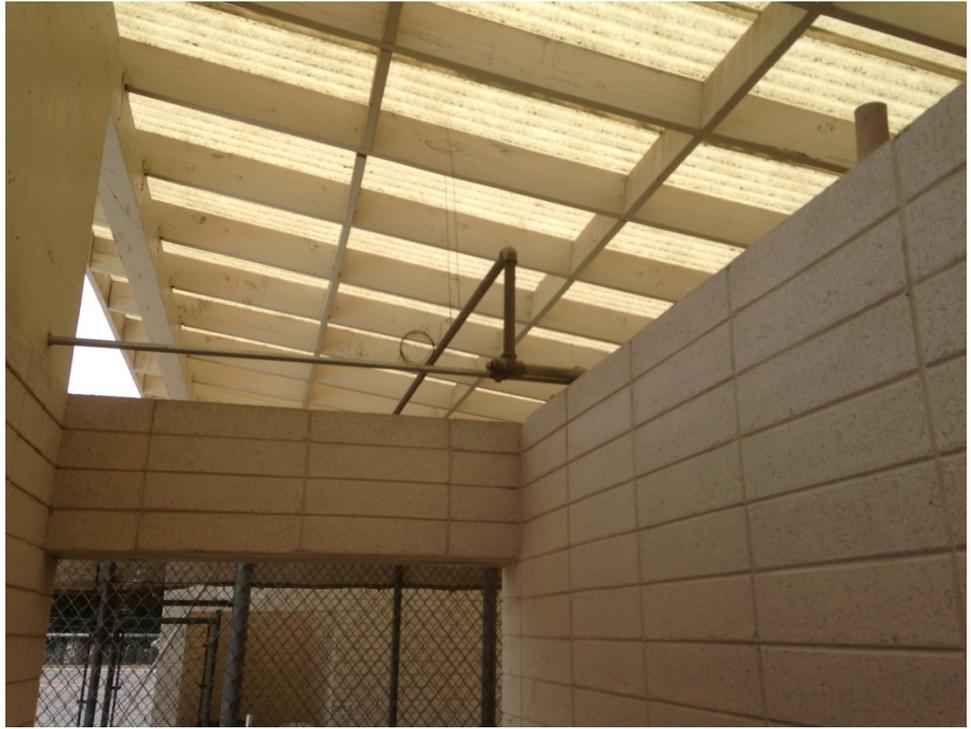
Photo 03
Bathhouse Light and Ventilation

2. Bathhouse:
 - a. No electrical light fixtures are provided in the bathhouse. Natural light is provided with the use of corrugated translucent fiberglass panels as the roof deck. *(See photo 03.)*

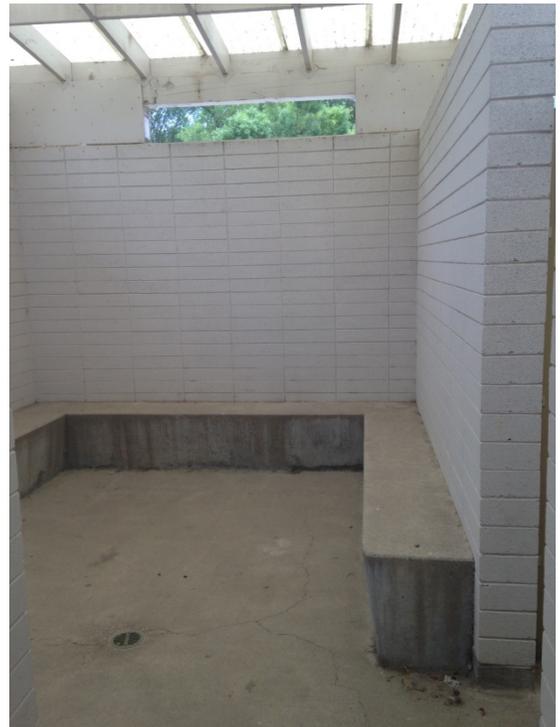
Photo 04
Changing Area Bench (typ.)

- 4) Each changing area provides a continuous bench along the perimeter walls. Lockers are not provided. *(See photo 04.)*
 - 5) Toilet Room fixtures provided:

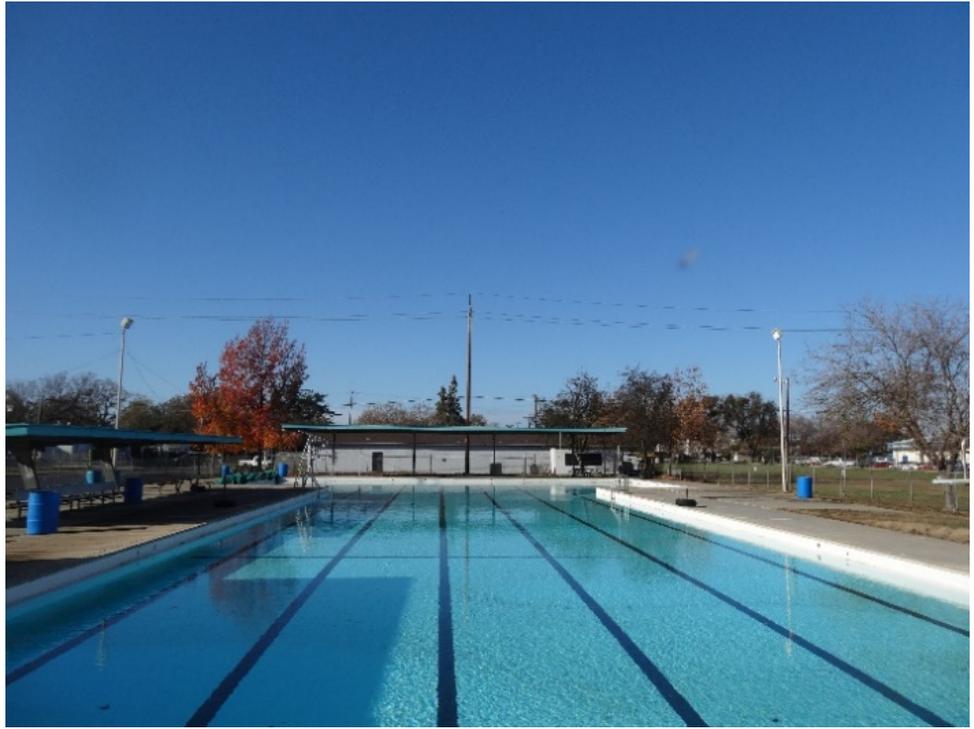
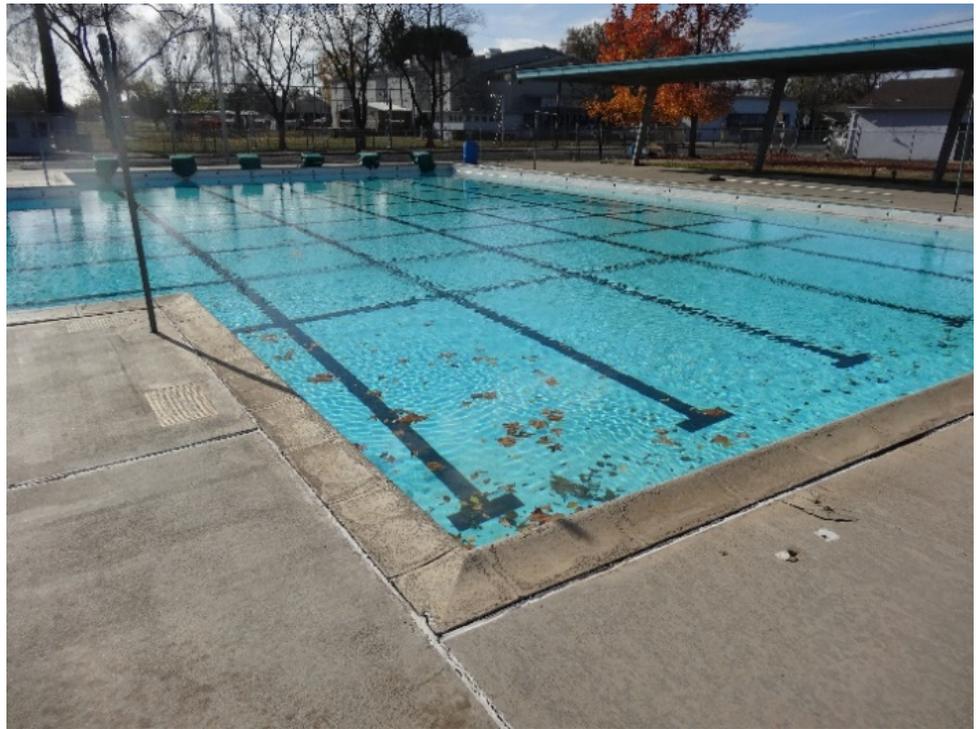
- a. The swimming pool was designed as typical in-ground reinforced concrete construction, 50 meters (164 feet) long, six (6) lanes by 42 feet wide, with a six (6) lane by 42 feet by 25 yard (75 feet) course at one end. The pool ranges in water depth from 3'-6" to 6'-6". The perimeter of the pool is 478 feet. Its surface area is 8,274 square feet and its volume is approximately 280,000 gallons. *(See photos 05, 06.)*

- b. The swimming pool shell is reinforced concrete with a white plaster finish. There is a continuous construction joint across the pool floor and up each poolside wall at the 5'-0" depth. There is a 6" contrasting paint band at the 4'-6" depth transition. There are six (6) 8" lane markers and lane targets painted in both the 50 meter and 25 yard directions. *(See photos 05, 06.)*

3. Swimming Pool:
 - a. The swimming pool shell is likely past its useful life. There are signs of repairs in two locations near the main drains. The swimming pools plaster finish appears to be past its useful life. There are multiple areas with signs of corrosion and staining. There are two locations near the main drains where the shell has been repaired and re-plastered.

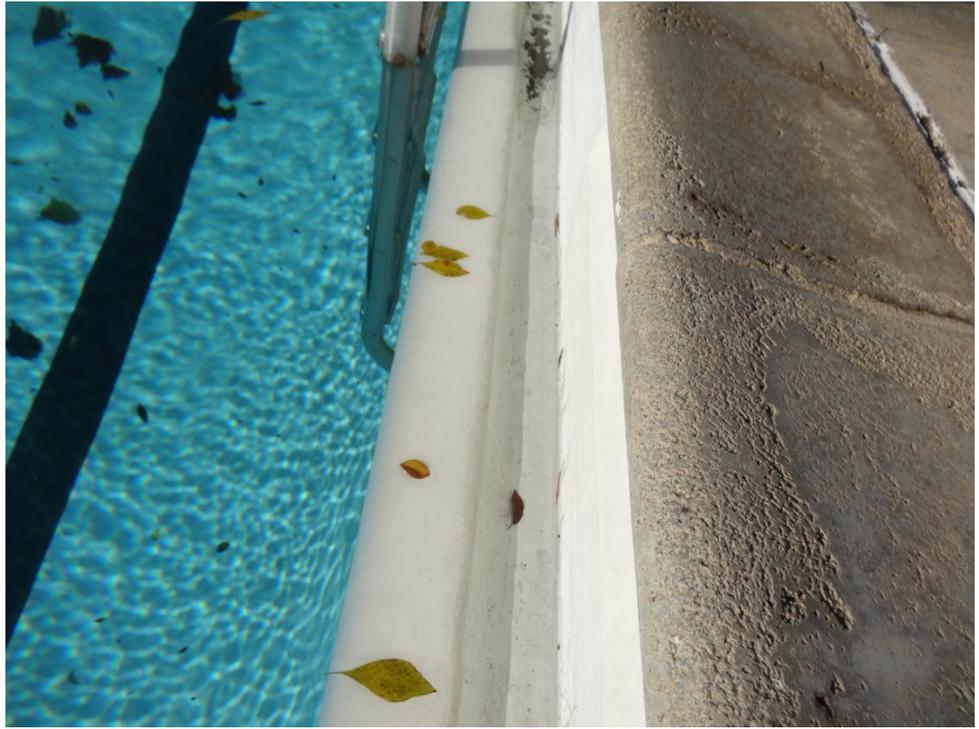
Photo 07
Scum Gutter

- d. The recirculation system is comprised of wall inlets, two 18" x 18" floor drains, and a perimeter scum gutter skimming system. The scum gutter is approximately 1.5" deep. *(See photo 07.)*

A scum gutter is an unprotected shallow gutter with drop outs at periodic intervals, usually between 8 and 12 feet spacing. The gutter poses a safety risk by being a slippery surface that prevents sure footing when entering or exiting the pool from points other than the ladders provided. Scum gutters are designed with a limited capacity for swimmer surge.

- e. The concrete coping partially hangs over the scum gutter and is 11.5" above the current water level. *(See photo 07.)*
- f. There are twenty cup-style lane line anchors, ten for the 50 meter course and ten for the 25 yard course. Two full reels were stored on the pool deck under a tarp.

- b. The scum gutter is flooded, not allowing for proper skimming effect that is necessary for proper circulation. The scum gutter system does not comply with the current CBC code. The overflow system does not meet the required surge capacity. The overflow channel is not deep enough in some locations. *(See photo 07.)*

- e. Re-use the existing pool structure: We suggest making alterations to the existing pool shell to meet all current code and programming requirements of NFHS swimming, including overflow channel replacement to meet code requirements and all new sanitation system equipment.

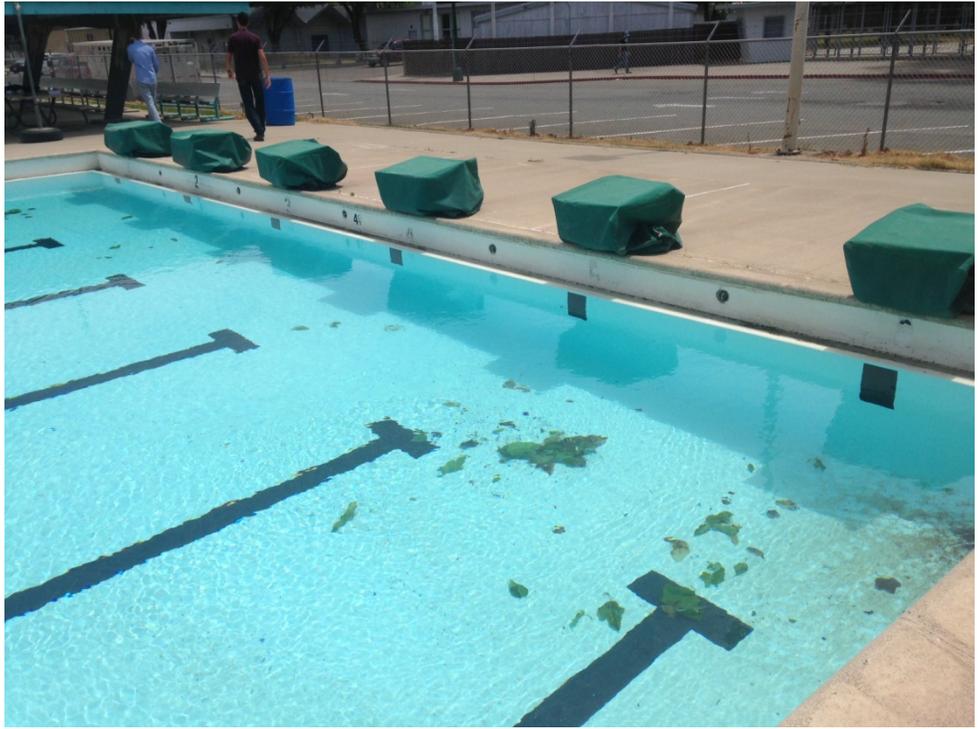
Photo 08
Stanchion

- a. The pool deck is constructed of reinforced cast-in-place concrete. The existing expansion joints are approximately 10 to 15 feet apart.
- b. There are four (4) stanchion poles at approximately the 5 yard marker on the 25 yard course. There are abandoned stanchion anchors at the shallow end of the 50 meter course. *(See photo 08.)*
- c. Six (6) starting blocks are anchored on the shallow end of the 25 yard course. There is electrical wiring hanging over the starting blocks and over the pool. *(See photo 09.)*
- d. There is one anchored lifeguard chair at the 6'-6" portion of the pool. *(See photo 10.)*

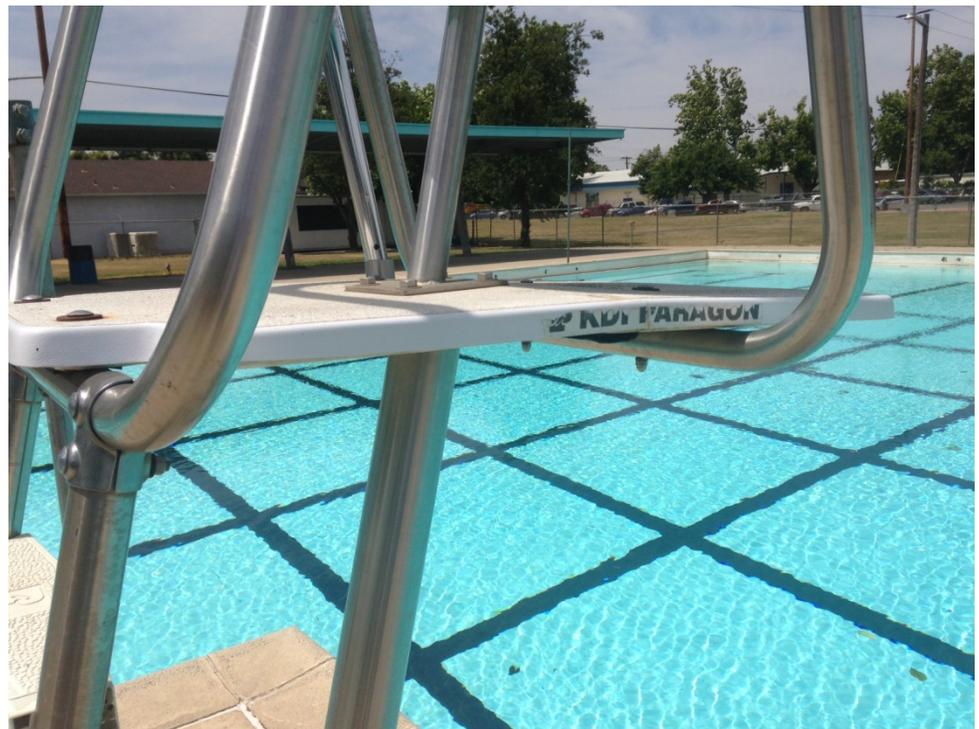
Photo 10
Lifeguard Stand

- e. There are no "No Diving" warning signs around the perimeter of the shallow areas of the pool.
 - f. The lifeguard chair is in a state of disrepair. *(See photo 10.)*

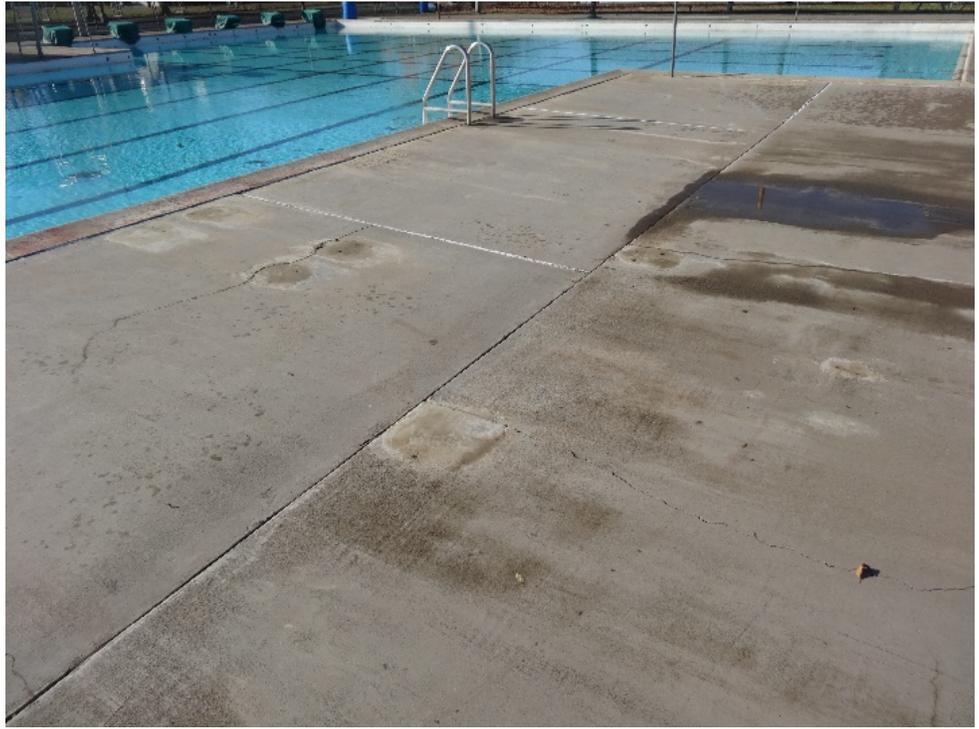
Photo 11
Slide Removed

- e. The pool deck showed evidence of the pool having a pool slide on the north side of the pool. The slide has been removed. *(See photo 11.)*
 - f. Mosaic tile depth markers are located around the pool's perimeter on the back of the coping. *(See photo 12.)*

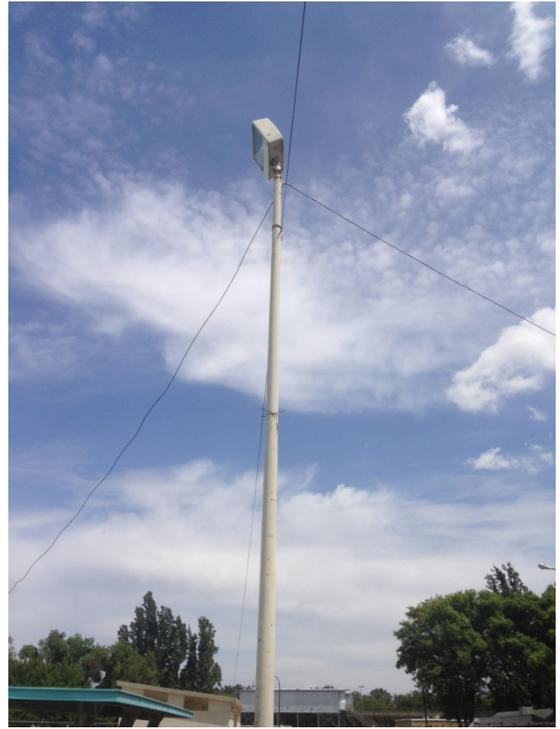
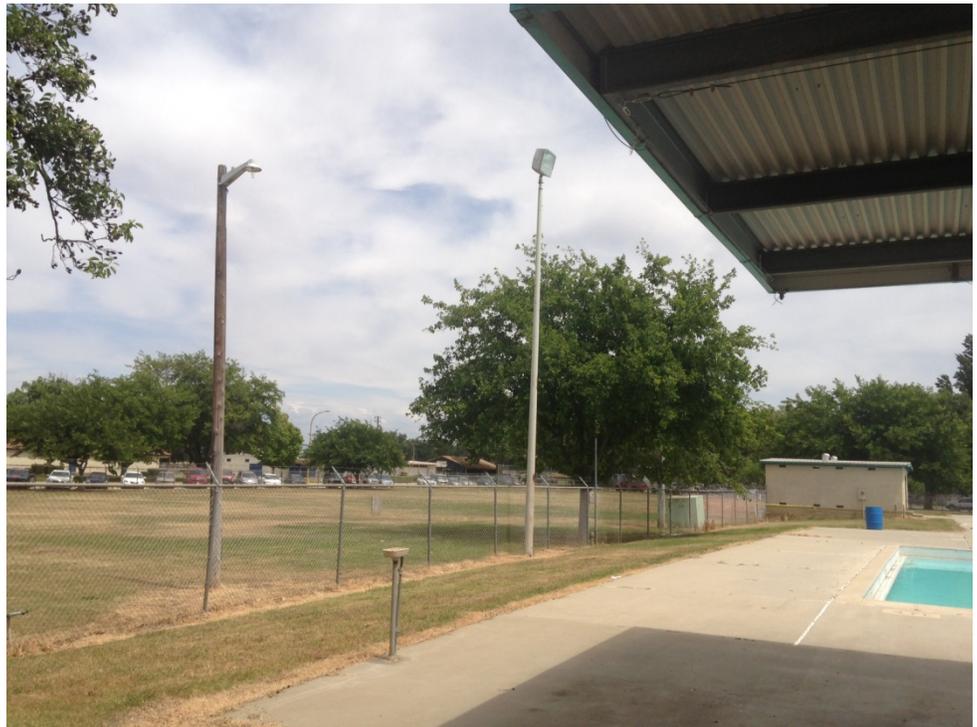
- g. There are two (2) overhead area lights provided to serve the entire pool site. *(See photos 13, 14.)*
5. Pool Equipment Building Shell:
- The pool equipment building was constructed with the construction of the pool in 1967. Masonry walls, wood framed roof and concrete floors make up the building shell. *(See photo 15.)*

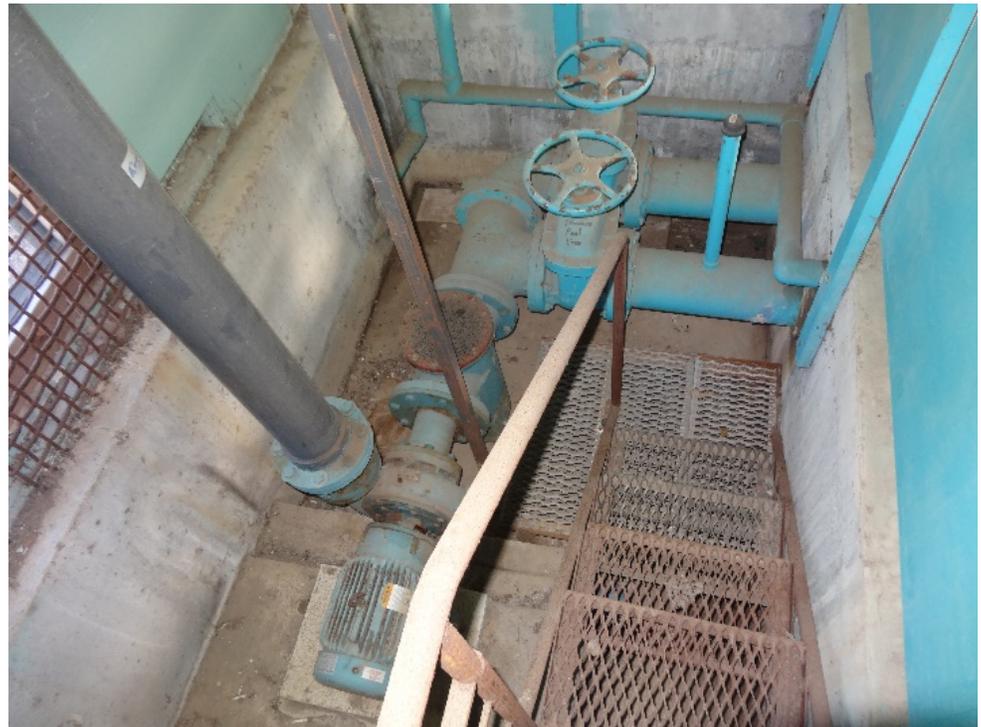
Photo 16
Suction Lines and Strainer

6. Swimming Pool Sanitation Equipment:
- a. Suction Piping: Original cast iron piping from main drain and scum gutter suction lines. *(See photo 16.)*
 - b. Return Piping: 6" PVC throughout mechanical room. Original cast iron return lines to pool. *(See photo 17.)*

- c. The existing cast iron suction piping and return piping is displaying signs of corrosion and may be contributing to water loss.
 - d. The PVC piping in the mechanical room is improperly supported and shows signs of leaks. There are no flow directional arrows, color coding, or piping schematic displayed. Valves are not tagged and labeled. (*See photo 28.*)

- 4) Replace the suspect cast iron suction piping and return piping.

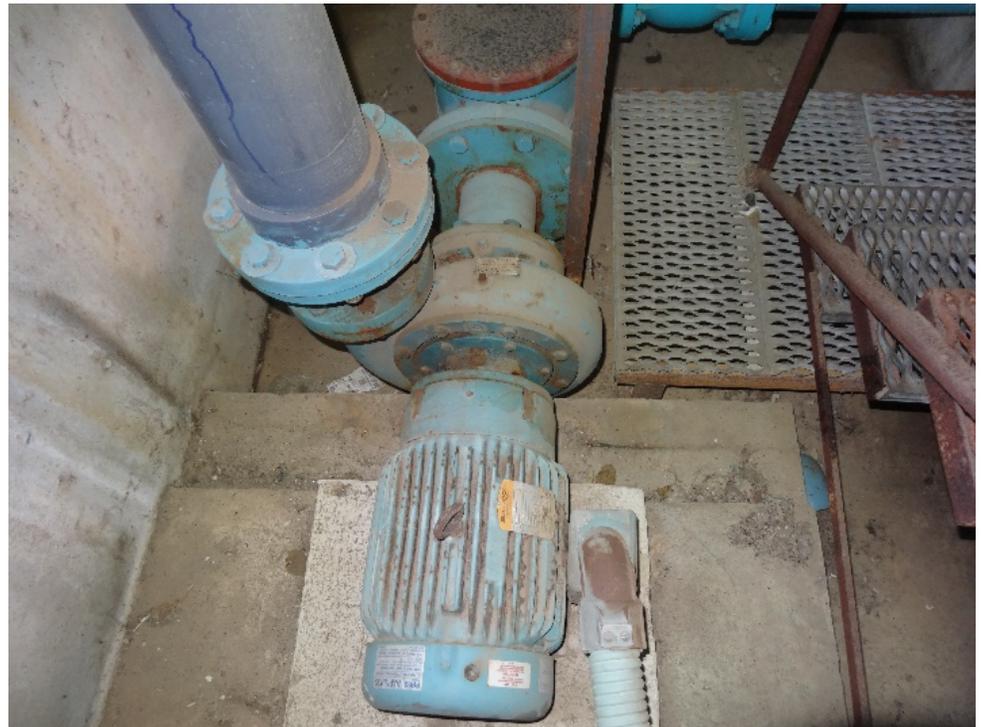
Photo 18
Pump

- c. Pump: PACO 15HP, 625 gallons per minute (gpm), 1750 revolutions per minute (rpm), 230/460 volt, 40-20 amp, with a strainer; plug flow reducer on suction side of pump. *(See photo 18.)*

- e. There is no knife disconnect within eyesight of the circulation pump. There are no pump gauges, isolation valves, or check valves at the pump. The pump strainer appears to be past its useful life.

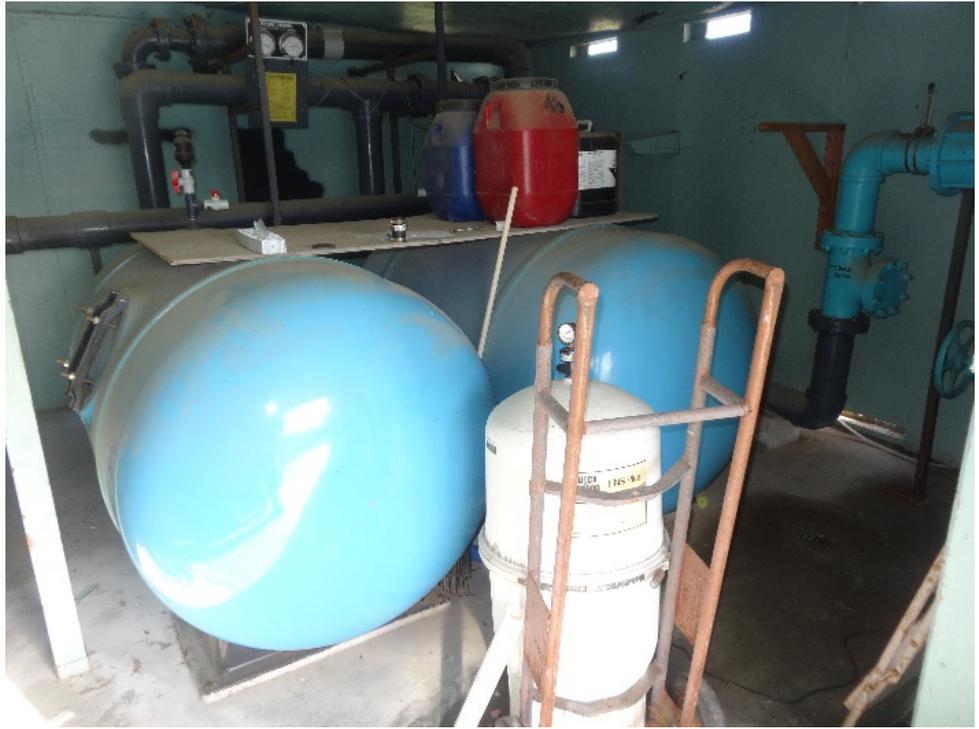
Photo 19
Sand Filters

- d. Filters: Two (2) Neptune Benson high rate sand filters. 48" diameter, 72" length. 55.4 sq ft filtration area each, 11.3 gpm per sq ft and 813 gpm backwash rate. *(See photo 19.)*

- h. The backwash piping is not sized properly for the rated backwash rate of 813 gpm. There is no air gap to the backwash pit.
 - i. The flow meter is not functioning and needs replacement.

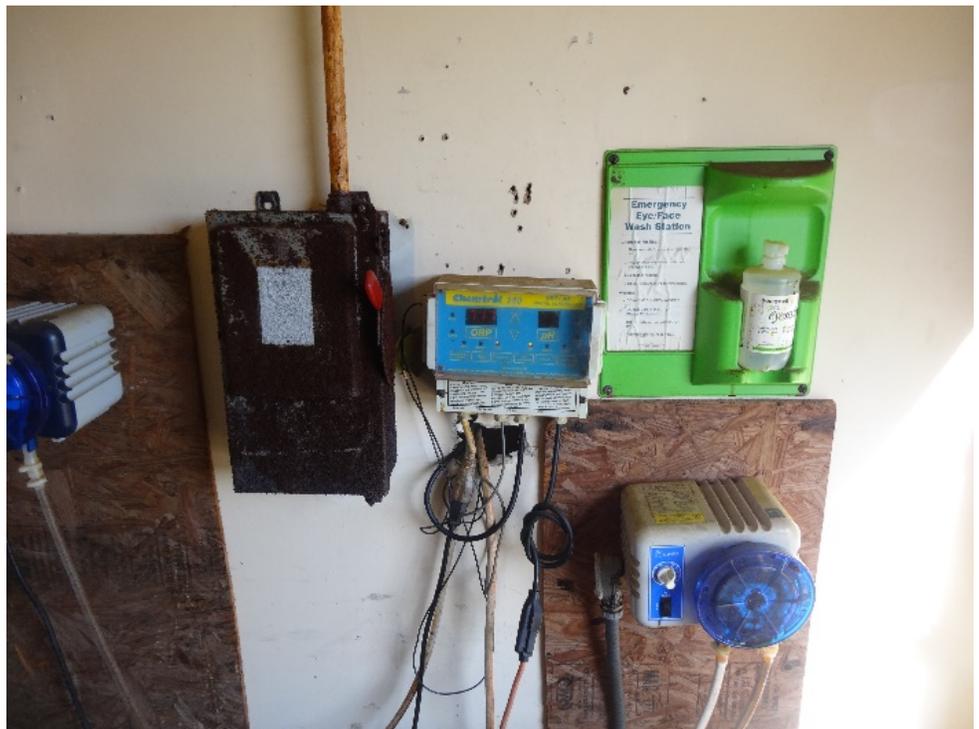
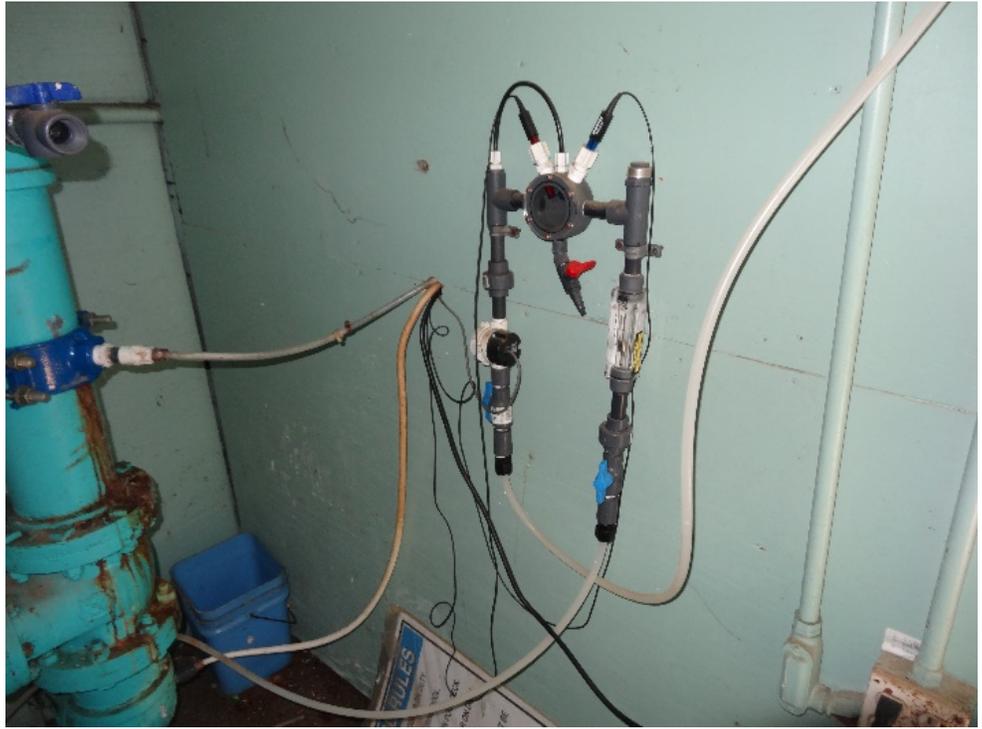
- e. Chemical Storage: Three (3) 53 gallon sodium hypochlorite containers; one (1) 30 gallon muriatic acid container.
 - f. Chemical Controller: Chemtrol 250 oxidation-reduction potential (orp)/pH controller with sensors, injectors. *(See photos 20, 21.)*

- g. Chemical Feeders: Rola-Chem pneumatic pumps, 38 gallons per day (gpd) liquid sodium hypochlorite and acid. *(See photos 20, 21.)*
 - h. Flow meter: Blue-White F series.

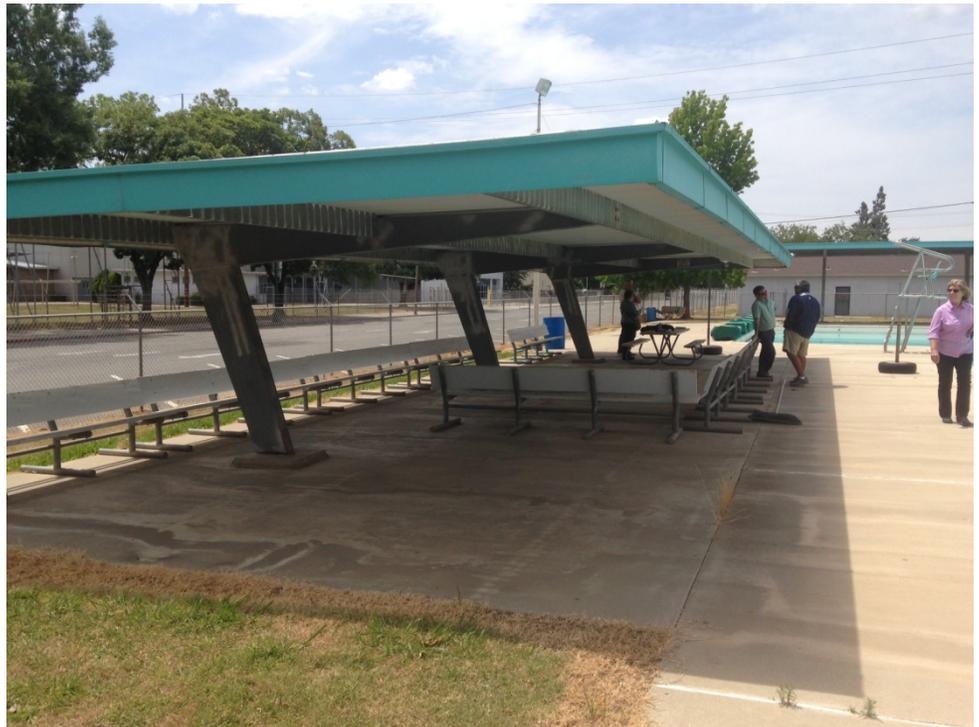
Photo 21
Chemical Sensors and Conduit

- 1. General:
 - a. The facility shows its age in terms of wear and tear, substandard maintenance and housekeeping, and what appears to be the minimum in repairs.
 - b. The roof of the bathhouse, pool equipment building, or shade structures were not inspected.
 - c. The structural designs of the existing shade structures have not been analyzed for code compliance. *(See photos 22, 23.)*
 - d. The existing facility is non-compliant with accessibility requirements.

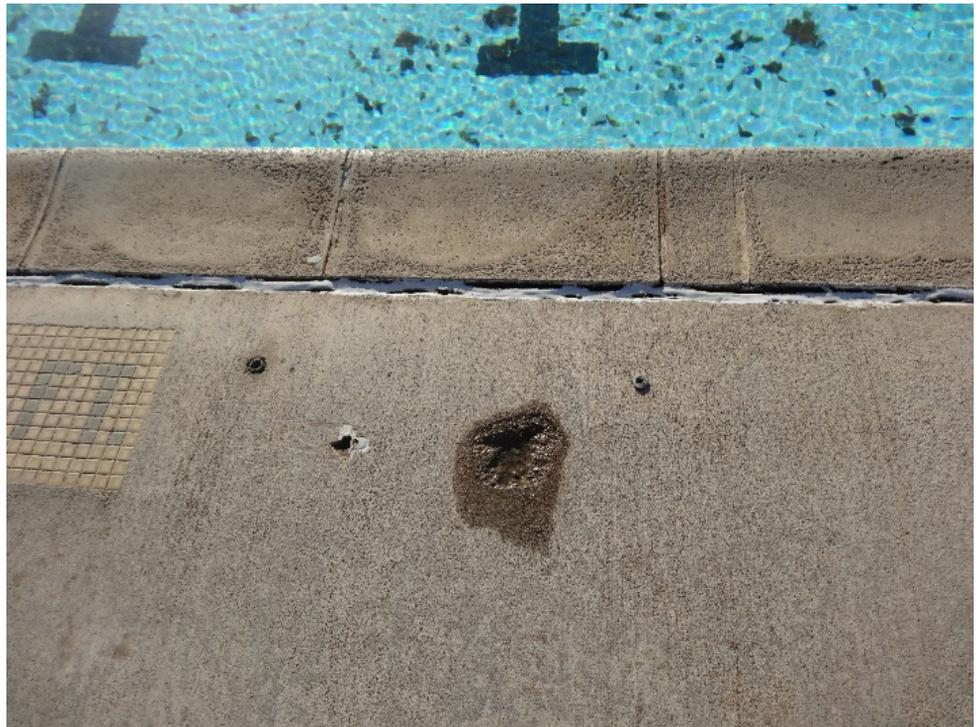
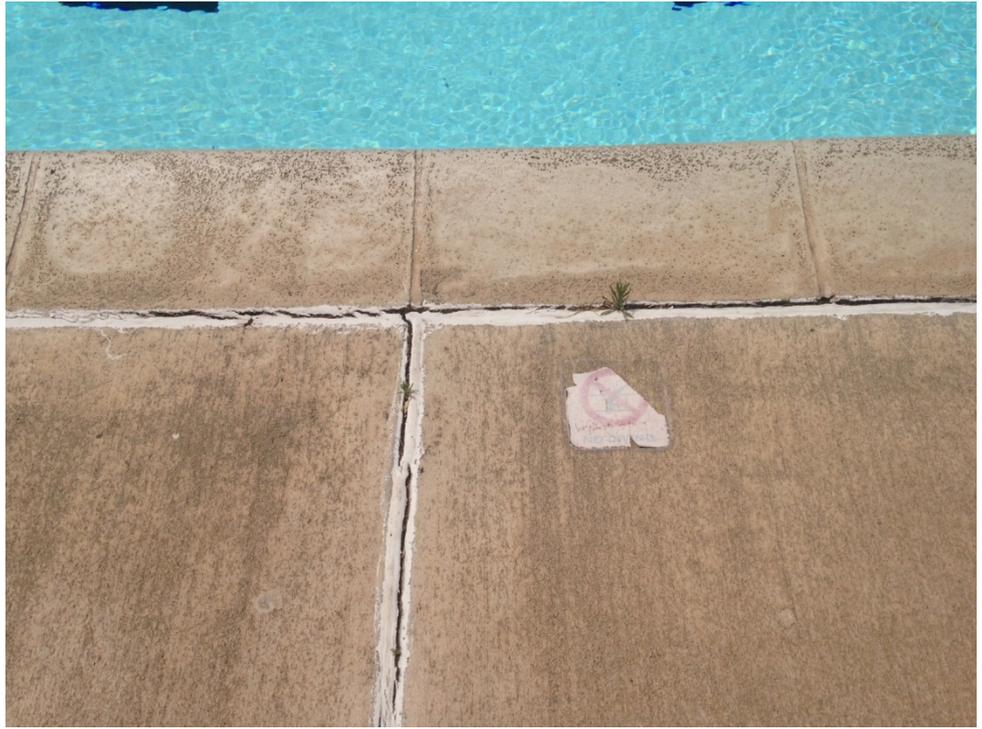
4. Pool Decks and Drainage:
 - a. The existing pool deck appears to be past its useful life. There are locations where the deck and coping is significantly uneven. There is significant cracking and erosion throughout the pool deck. *(See photos 24, 25.)*

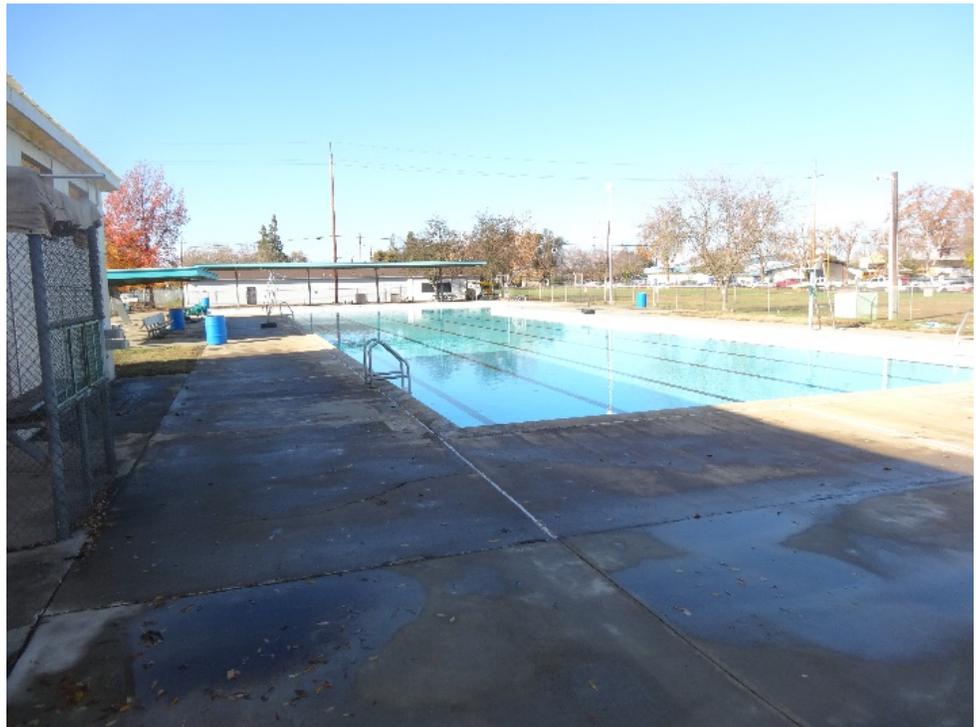
Photo 26
Deck Ponding

- b. There are no drains or deck drainage system in place. There are visual areas of water ponding throughout the pool deck. *(See photo 26.)*
 - c. The starting blocks are located at the southwest corner of the pool, where water depths vary from 4 feet to 5 feet, significantly too shallow for diving starts. Industry standard requires a minimum of 6'-6" of water depth for starting blocks.

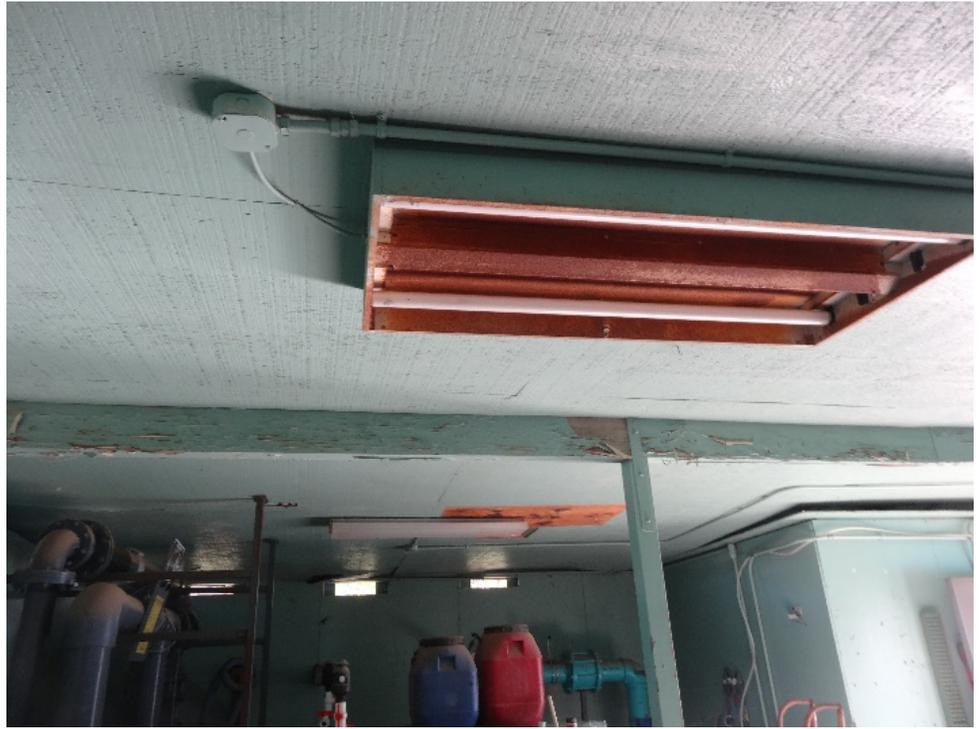
Photo 27
Equipment Room Lighting

5. Pool Equipment Building:
 - a. There is inadequate lighting and ventilation for the pool equipment room. (*See photo 27.*)
 - b. There is only one floor drain in the equipment room which appears to be clogged. There is visible water ponding and erosion of the concrete floor.

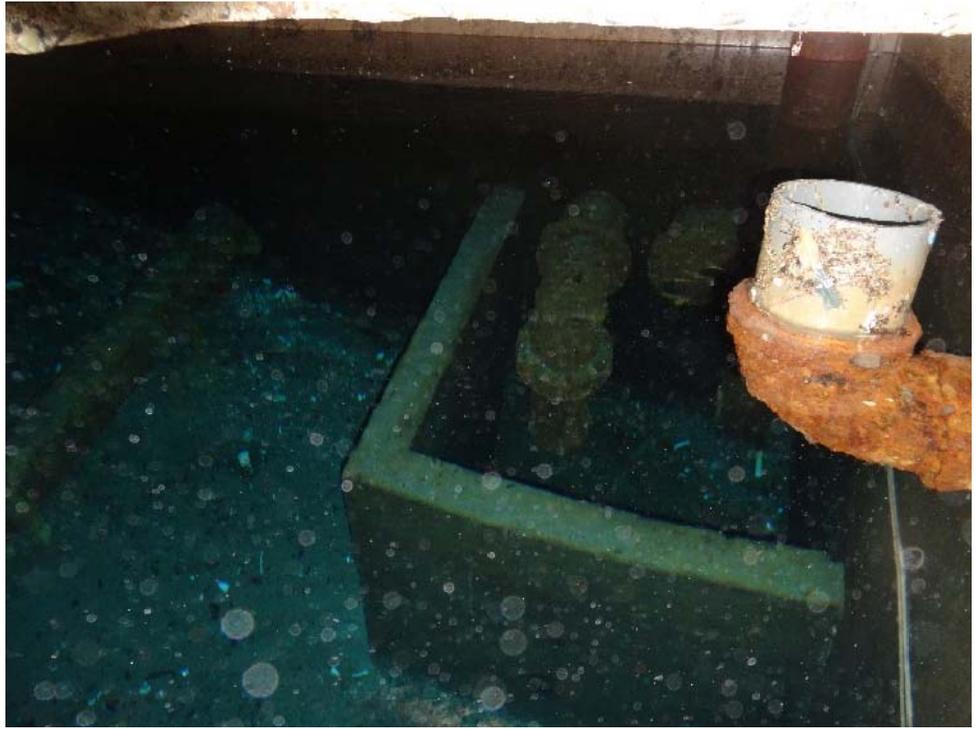
Photo 29
Balance Tank

- f. The balance tank is flooded. There is no access to the valves inside the balance tank. (*See photo 29.*)
 - g. The fill system is not properly operating and needs repair.

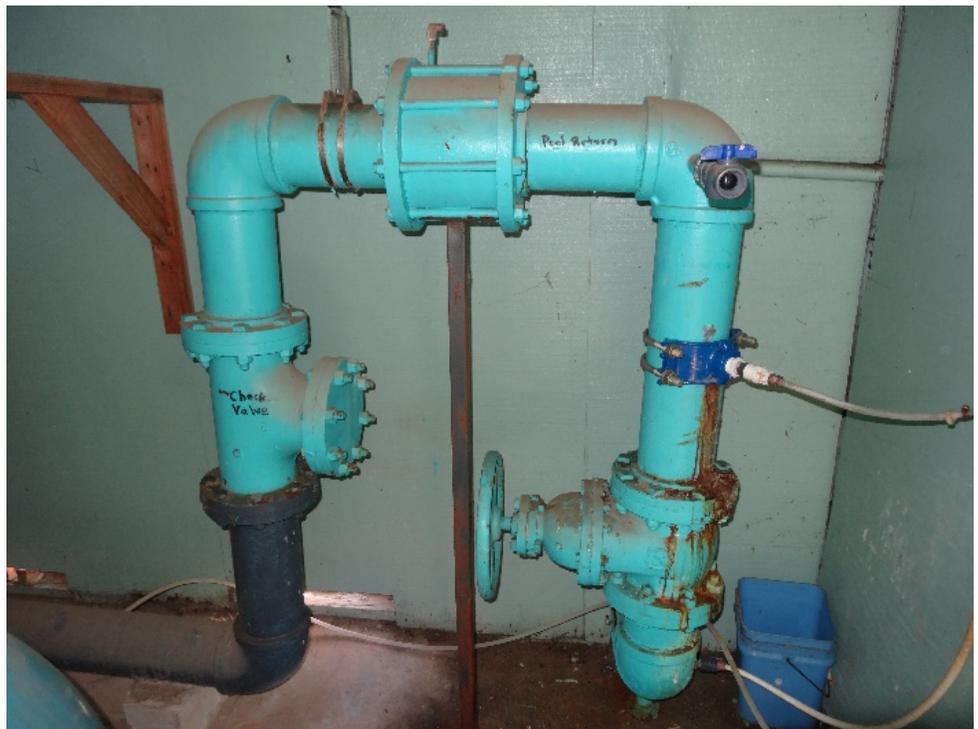
Photo 30
Chemical Injectors

- j. The chemical injectors are not properly installed and show signs of leaking. Conduit is not properly supported. (*See photo 30.*)
 - k. The pool chemicals are improperly stored on top of filter tanks. Acid is stored in the same room as sodium hypochlorite. The rooms have improper hazmat signage. Required signage is missing.
